Lichens and other lithobionts on the carbonate rock surfaces of the heritage site of the tomb of Lazarus (Palestinian territories): diversity, biodeterioration, and control issues in a semi-arid environment

**LICHENS AND OTHER LITHOBIONTS ON THE CARBONATE ROCK SURFACES OF
THE HERITAGE SITE OF THE TOMB OF LAZARUS (PALESTINIAN TERRITORIES):
DIVERSITY, BIODETERIORATION AND CONTROL ISSUES IN A SEMI-ARID
ENVIRONMENT**

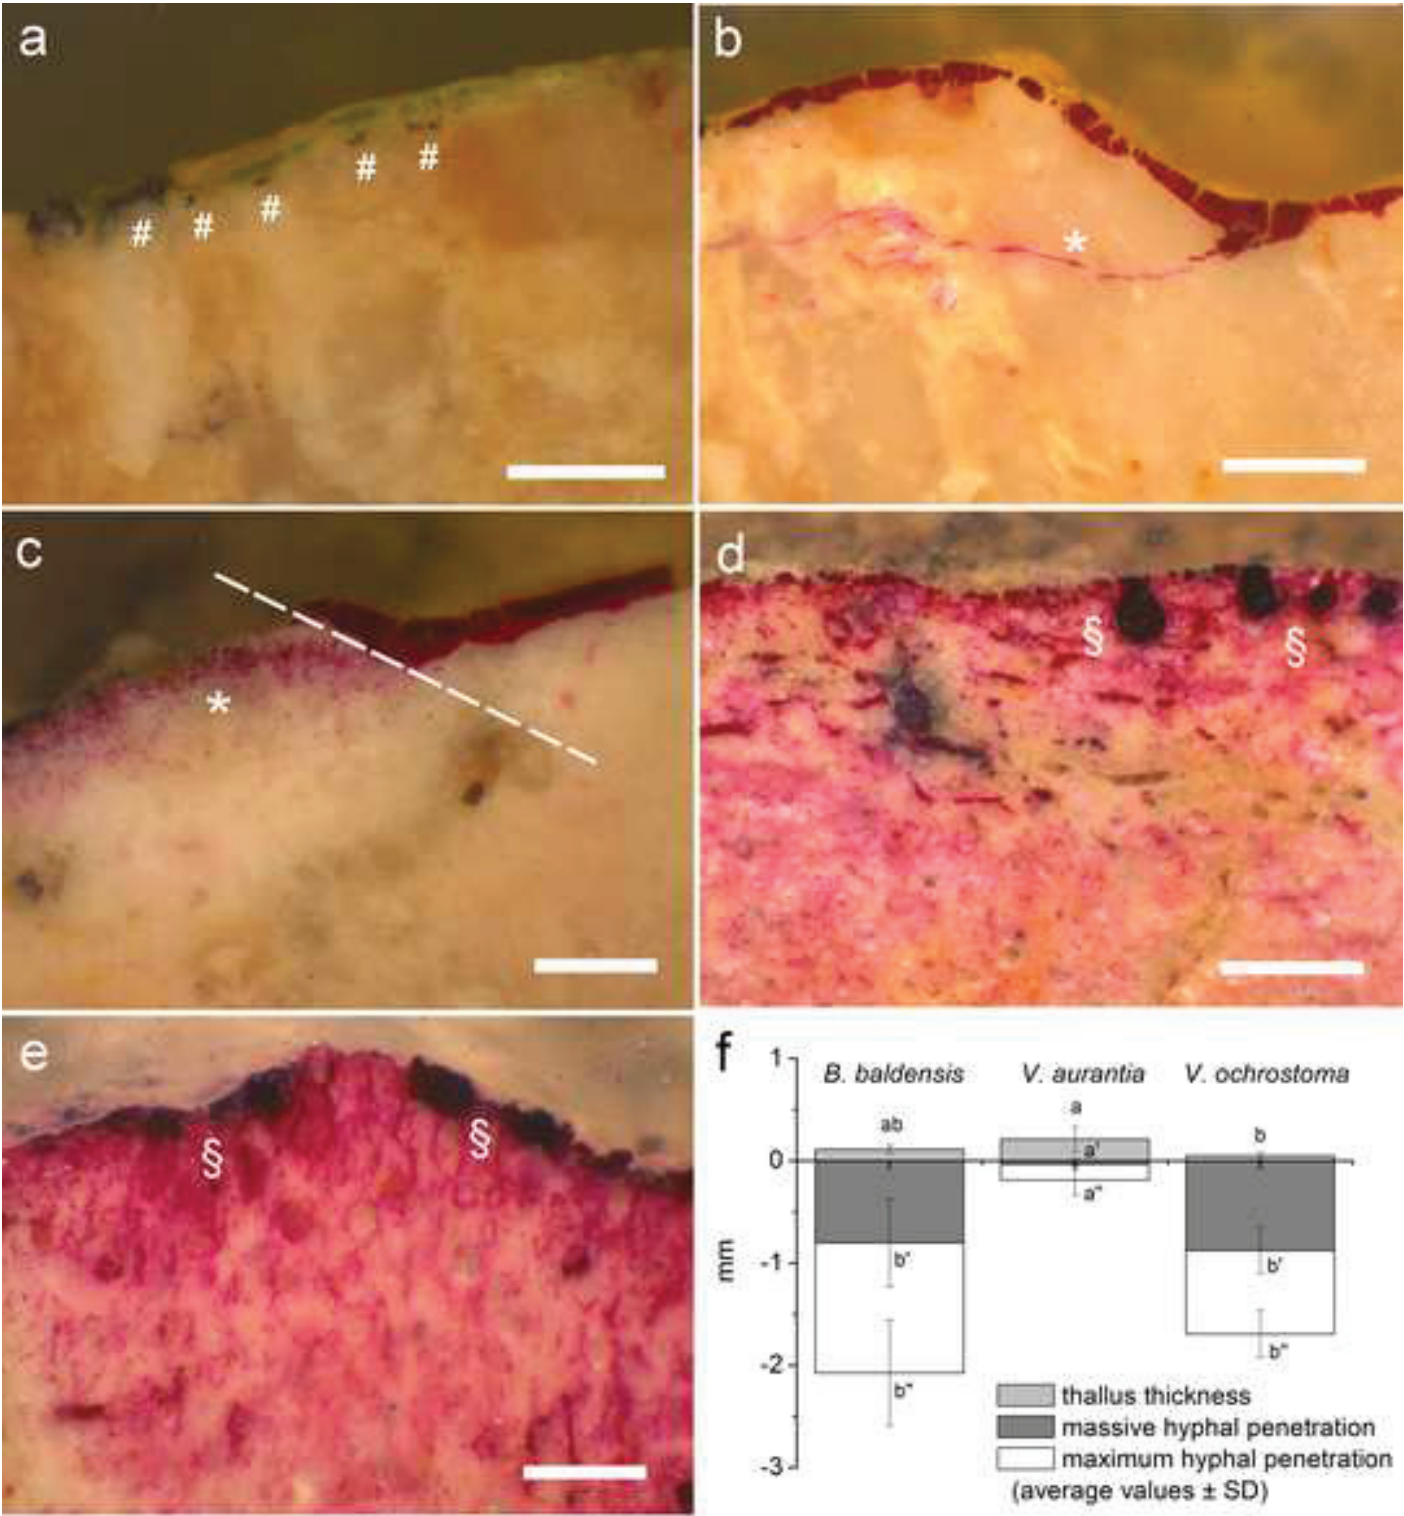
Figure 4

733 Fig. 4 Interface between lichens and the Jerusalem stone (cross sections observed by RLM). **a** Free
 734 colonies of dematiaceous fungi (#) beneath a thallus of *Variospora aurantia*. **b-e** Hyphal
 735 penetration component of epilithic and endolithic lichens (cross sections stained by PAS,
 736 visualizing biological structures in violet): **b**, *Variospora aurantia* (*, hyphal penetration limited to
 737 a crack), **c**, *Pyrenodesmia erodens* (left) and *V. aurantia* (right), **d**, *Bagliettoa baldensis* (§,
 738 perithecia), **e**, *Verrucaria ochrostoma* (§, perithecia). Scale bars: 0.5 mm (**a**, **c**, **e**), 1 mm (**b**, **d**). **f**
 739 Quantitative characterization of the specific structural organization (av. thallus thickness, massive
 740 and maximum depth of hyphal penetration component). For each parameter, columns which do not
 741 share letters are significantly different (ANOVA, Tukey's test, $p < 0.05$).

RLM observations at the lichen-substrate interface showed a different structural organization of the epilithic *V. aurantia* and endolithic species (Fig. 4). The former displayed a thicker thalline component (av. 0.2 mm), but its hyphal penetration component (HPC sensu Favero-Longo et al. 2005) was scarce, characterized by an av. depth of massive penetration of 0.03 mm and av. values of maximum penetration of 0.2 mm (Fig. 4b-c). In some cases, local staining of biological structures within the substrate beneath the *V. aurantia* thalli corresponded to free colonies of dematiaceous fungi, already observed for their coloured appearance before the PAS treatment, and not to mycobiont penetrating hyphae (Fig. 4a). By contrast, only a thin lithocortex and discontinuous thalline structures (av. thickness \leq 0.1 mm) were visible on surfaces colonized by the endolithic *B. baldensis* and *V. ochrostoma*, respectively. Both the species showed a remarkable hyphal penetration component, massively penetrating the substrate down to av. depths of 0.8 mm and with maximum penetration av. values of 2.1 and 1.7 mm, respectively (Fig. 4d-e). Moreover, their perithecia endolithically developed down to 0.3-0.4 mm, their growth appearing the potential

responsible for pitting phenomena sparsely observed on the carbonate blocks through the site. Massive hyphal growth through the carbonate matrix, rather than limited to intragranular porosities or rock fractures (as sometimes observed for *V. aurantia*) characterized both endolithic species. It is worth noting that strong penetration of endolithic thalli (like those of *Pyrenodesmia erodens* in Fig. 4c) growing adjacently to *V. aurantia*, which shows negligible hyphal penetration component, indicates that the different species, rather than variations in substrate properties, are responsible for the heterogeneous structural organizations of the different *taxa* above and beneath the rock surface.

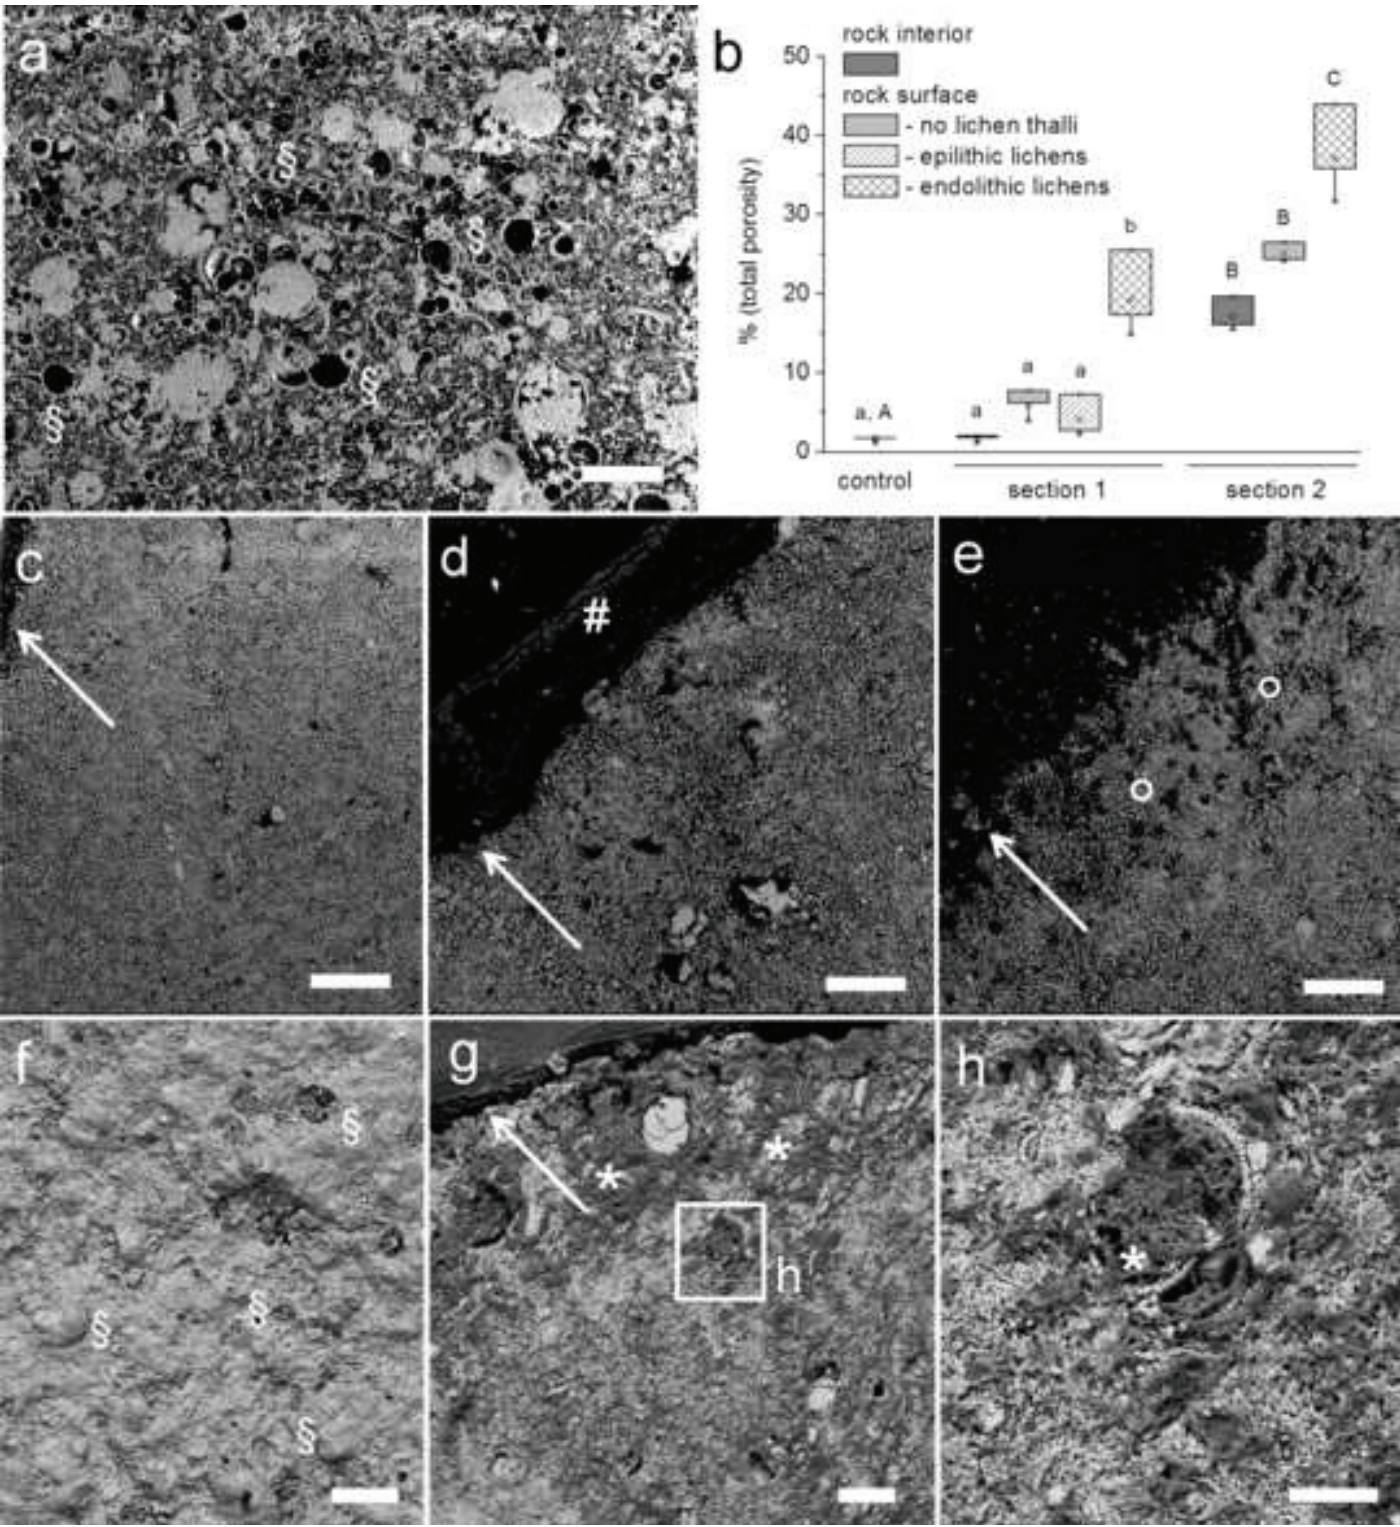
742 Fig. 5 Lichen effect on the total porosity of the Jerusalem stone (sections observed by SEM-BSE). **a**
 743 Petrographic thin section of a fresh fragment, showing porosity internal to bioclats (§). **b**
 744 Quantitative characterization, based on image analysis, of the total porosity of: a 300 µm layer
 745 beneath the surface showing the epilithic *Variospora aurantia*, the endolithic *Pyrenodesmia*
 746 *erodens*, and absence of lichens (polished cross section 1); a 300 µm layer beneath the surface
 747 showing the endolithic *Bagliettoa baldensis* and absence of lichens (section 2); 300 µm layers at
 748 more than 2 mm from the surface (sections 1 and 2); 300 µm layers of fresh fragments as control.
 749 For each section, columns which do not share letters are significantly different (ANOVA, Tukey's
 750 test, $p < 0.05$). **c-e** BED-C images of section 1: **c**, rock surface (arrow) not colonized by lichen thalli,

SEM-BSE observations of the petrographic thin sections showed the bioclastic structure of the Jerusalem stone and a remarkable porosity internal to bioclasts (Fig. 5a). The polished cross sections of the same fresh fragments highlighted that the microfossils are tightly embedded within a fine-grained calcite matrix (Fig. 5f). The massive hyphal penetration by endolithic lichens affects the total porosity of the upper rock layers (Fig. 5b). The 300 μ m layer penetrated by *P. erodens* (Fig. 5e) and *B. baldensis* (Fig. 5g-h) beneath the rock surface showed significantly higher values of total porosity than those covered by *V. aurantia* (Fig. 5d) or not colonized by lichen thalli (Fig. 5c). Such endolithic effect was observed on both section 1, which in absence of *P. erodens* showed a low total porosity similar to control sections, and section 2, showing a total porosity higher than control sections even at depths lower than 2 mm from the surface. BED-S observations confirmed the hyphal penetration through the rock matrix (Fig. 5g) and showed the hyphal invasion of the bioclast internal porosity (Fig. 5h).
